**Technology Development  
and  
Demonstration  
of a  
Low Thrust Resistojet  
Thruster**

by  
**G. R. Pfeifer**

**The Marquardt Company  
Van Nuys, California**

**NATIONAL AERONAUTICS AND  
SPACE ADMINISTRATION  
LANGLEY RESEARCH CENTER**

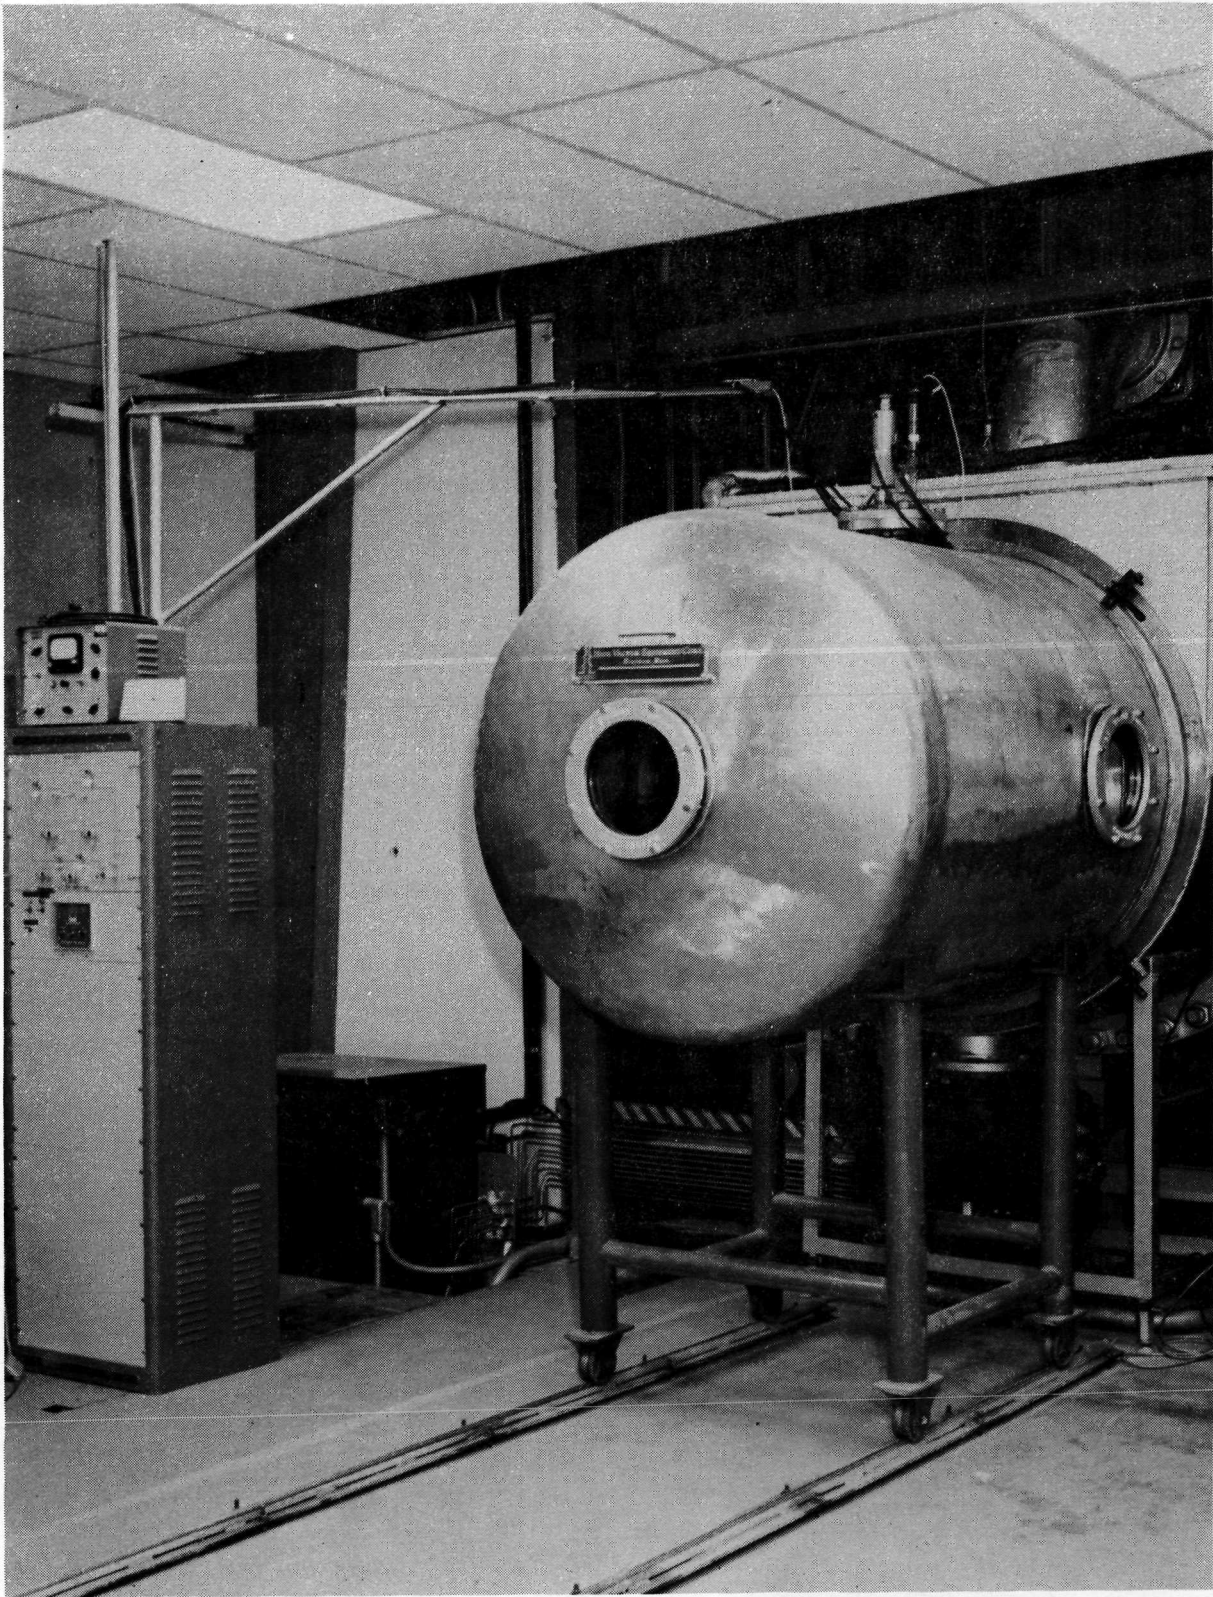
FIGURE 29. ELECTRICAL PROPULSION LABORATORY VACUUM  
TEST CHAMBER
